Lesson Learned: Fracturing Story Continues in Completely New Telisa Formation in B Structure South Sumatera

Reza Alfajri¹, Areiyando Makmun¹
 Pertamina¹

JOINT CONVENTION BANDUNG (JCB) 2021

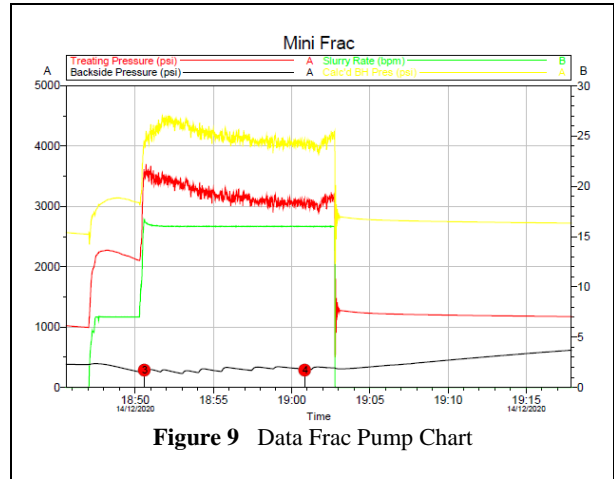
Figure 9 Data Frac Pump Chart

Mini frac was performed to analyze net pressure and fluid efficiency to be later used in final fracturing design. While break down test and step rate test utilized 4% KCL as the pumped fluid, data frac used frac gel. Pumping operated at 16 bpm with total of 231 bbls pumped fluid volume. Figure 9 shows that the gap between pressure before the pump was shut in (around 4200 psi) and the Bottom hole Instantaneous Shut in Pressure (ISIP) (2855 psi) was the total NWB friction. It means there are still around 1400 psi NWB friction handicap to handle in this well.

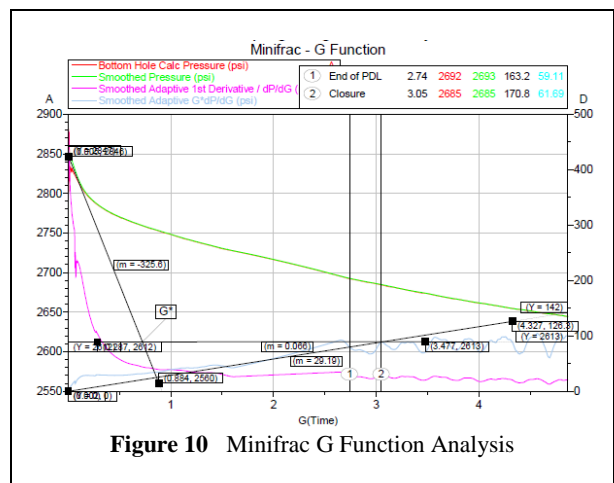
Figure 10 Minifrac G Function Analysis

Figure 10 shows mini frac G function analysis. From the chart it can be seen that decline curve shows concave up shape, which indicated presence of fissures in the reservoir. Because of this irregularities, instead of taking G closure from dP/dG or $G dP/dG$, G time was taken from the interception of the line from bottom hole ISIP to the $3/4$ point between bottom hole ISIP and closure pressure and the closure pressure line from $G dP/dG$ or dP/dG . This G time was called G^* . From G^* calculation of fluid efficiency was 27%. Fluid efficiency calculation from G closure on $G dP/dG$ curve was 61%. Since this is the first fracturing in Telisa formation B Structure and no previous reference, fluid efficiency for design was the average between G^* calculation and G closure calculation, which was 44%. Pad ratio was then calculated to be 39%. From minifrac data, final design for main frac was laid out as shown in Figure 11 and 12.

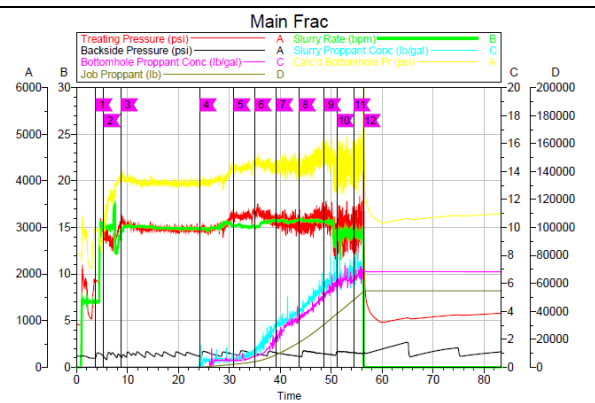
Figure 13 Main Frac Pump Chart

Figure 13 and 14 show that erratic treating pressure started from 3-4 ppg slurry stage that forced a decrease in pumping rate in 6-7 slurry stage, and the pumping ultimately ended because of early screen out at 7 ppg slurry stage on minute 56th. The erratic treating pressure was suspected either due to pump problem or because outside material was accidentally pumped into the fracturing system. Investigation was carried out in order to know the root cause of early screen out as well as erratic treating pressure behavior that preceded the screen out. Figure 15 shows summary of the main treatment.

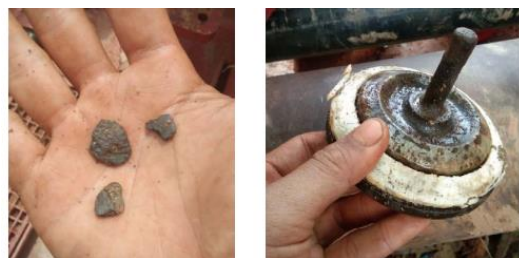
Figure 15 show that 44,701 lbs proppant was successfully pumped into formation (69% of 65,000 lbs design). After performing investigation, improper suction frac valve condition was found. The root cause for this was solid material that was accidentally pumped during the frac job and stuck inside frac valve (Figure 16). All of the equipment was checked prior to the job and in a good condition. Due to alien material that was found in the investigation, precautions were planned to prevent this to happen in the future by installing screens / filters on the fresh water tank and on suction blender.

Figure 16 Investigation Result Showed Improper Suction Frac Valve Condition due to Unwanted Pumped Solid Material

- Screens / filters were installed when receiving fresh water from vacuum truck and on suction blender to prevent solid material from outside entering fracturing system.

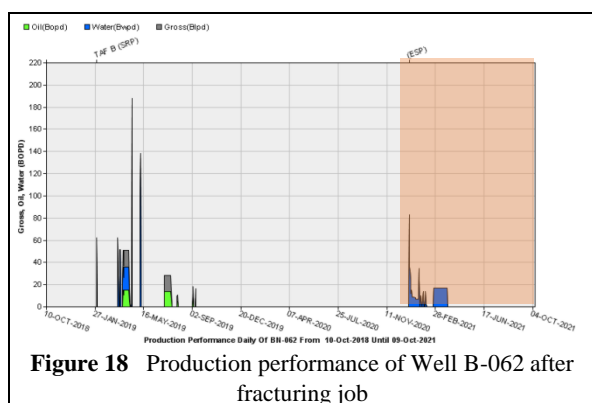
Figure 18 Production performance of Well B-062 after fracturing job

Figure 18 shows production performance of Well B-062 after fracturing job. Production under orange shade the well's performance after fracturing job. It can be seen that the well was still in unloading pumped fluid/gel phase. Total fluid recovered was only 564 bbls from total 1408 bbls fluid (980 bbls frac gel) pumped during the job. The well could not be produced anymore due to fines migration combined with the failure in meeting the fracturing design.
