JOINT CONVENTION BANDUNG (JCB) 2021

Reactivation of Gas Well With Lower Master Valve Problem Using Hottapping Method

Reza Alfajri¹, Sakti Parsaulian Siregar¹
Pertamina¹

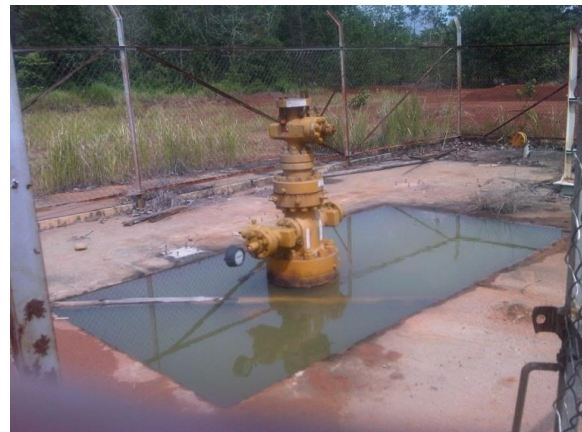
Figure 1 Well M-03 Condition

that can put safety at risk. Figure 1 shows the condition of suspended well M-03.

Well integrity is “the qualification that testifies to the well’s sound capability to perform its function to contain and control the flow of fluids within the predetermined barriers throughout its designed life” (Sultan 2009). Since lower master valve in well M-03 could not perform its function, it means that M-03 had well integrity problem. Therefore well intervention was needed.

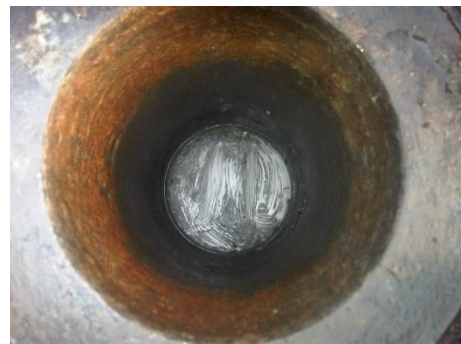
Figure 3 Stuck disk of the problematic lower master valve

M-03 is a gas well in M structure Pertamina that had failure in its lower master valve. This well was forced to stop producing due to problem in lower master valve. The disk in the lower master valve was stuck in closed position so that the well couldn't produce. The problem escalated once the valve's condition deteriorated. It started leaking gas that made a hazard to the surroundings. For safety reason, an action needed to be taken, however there was no path to kill the well. An alternative solution was needed to solve the problem.

Before the job, the above part of the master valve was cleaned and dried so that no debris on the soon to be drilled valve's disk.

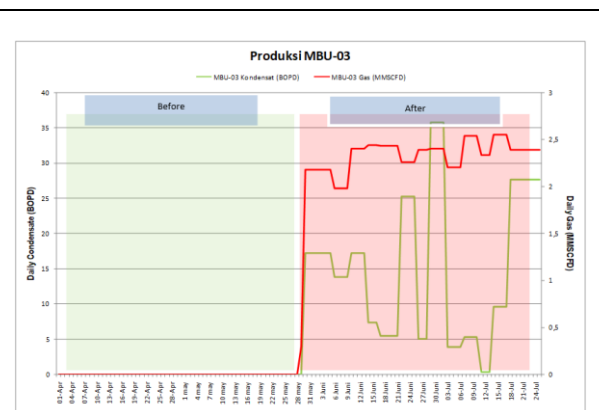
Figure 11 Well M-03 Production Performance Before and After the Job

Well test and monitoring was performed after Well M-03 was back on production. Figure 11 shows production performance before and after the job.

It can be seen that average production of Well M-03 was 2.34 MMSCFD and 14.91 bopd.

Gas handling in Gas Compressing Station in M structure has maximum allowable gas temperature to be allowed entry, which was 130° F. Average temperature of Well M-03 was 120° F, hence the restriction did not apply for its gas.

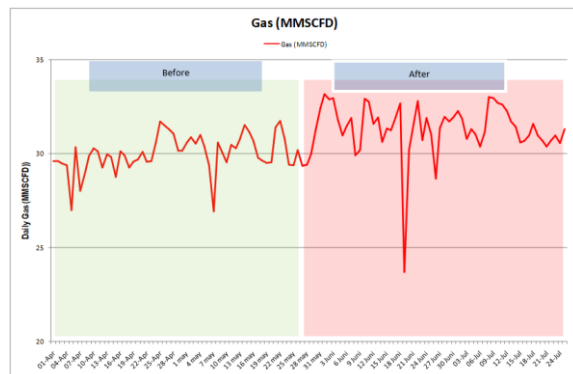
Figure 12 M Structure Production Performance Before and After Reactivating of Well M-03

Therefore, putting Well M-03 successfully added the whole structure gas production from 29.98 to 31.34 MMSCFD. Figure 12 shows M Structure gas production before and after putting Well M-03 back on production.

Figure 11 and 12 show that this project was successfully carried out safely. Aside from economical aspect of added gas production, safety aspect in term of well integrity was also successfully regained. Furthermore no disturbance to the active gas reservoir, so this method was also a success in reservoir management aspect.
