Pressure Activated Sealant to Restore Tubing Integrity – case study of well TN-x in Mahakam

¹Well Integrity Engineering, PHM

²Well Intervention Engineering, PHM

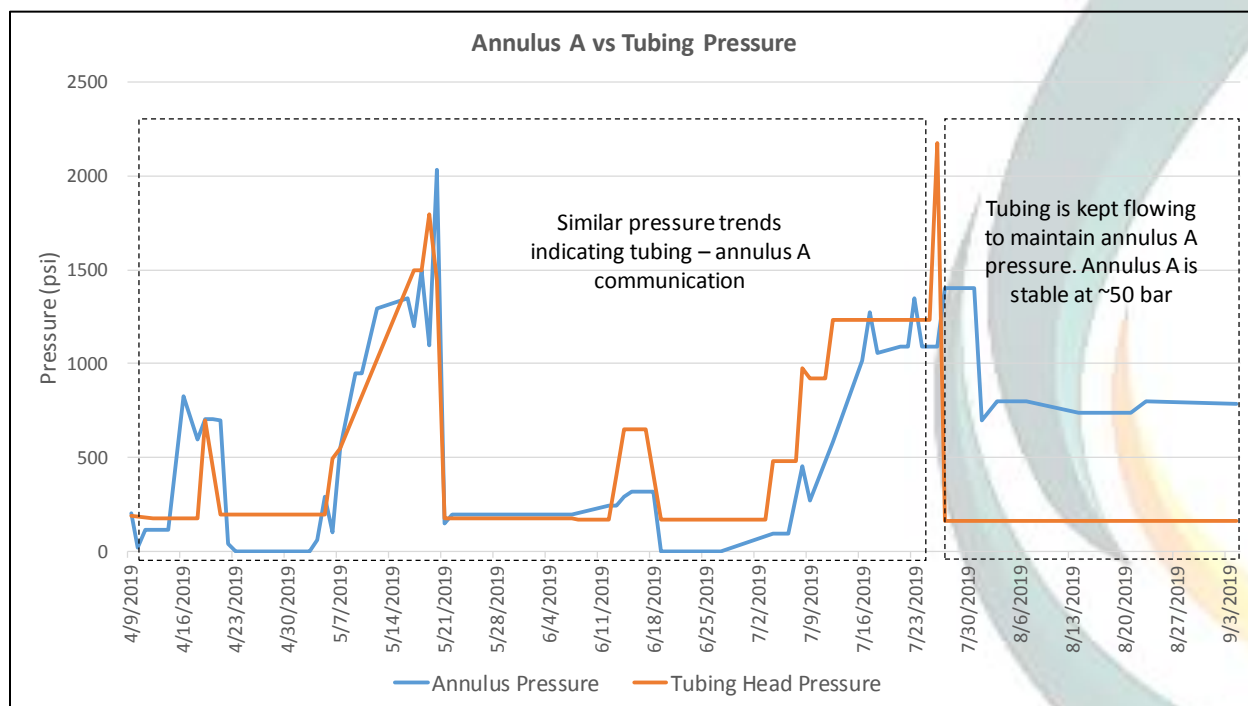
The first abnormal pressure recorded in Annulus A was on 8th of April 2019. Annulus A pressure rises to 1378 psi (92% from MAWOP) after additional perforation (Shut-in Tubing Head Pressure/ SITHP = 2139 psi). Annulus A pressure then was bled off to 72 psi and observed for 24 hrs while flowing the well (Flowing Tubing Head Pressure/ FTHP = 189 psi). After 24 hrs, the pressure was found rise to 200 psi. Annulus leak rate measurement was performed using Dwyer flow meter, and found low gas leak rate (<3 scfm, standard cubic ft per minute), which is below the flow meter scale range. Then several bleed off and Pressure Build Up (PBU) monitoring was conducted while intervention was being performed in the tubing. The correlation between tubing pressure and Annulus A pressure is shown on Figure 3. The similar pressure trend observed indicates communication between tubing and Annulus A.

Figure 3. Similar trends between Annulus A and Tubing Pressure before the intervention, indicating communication between tubing and annulus

In order to confirm the communication, well intervention unit is deployed to perform survey with Production Logging Tool (PLT). The leak depth indicated by PLT then was confirmed by setting plug at several depths near the leak point, then pressure tested to observe the tubing – annulus pressure communication. When the plug was set at 189 mMD, tubing was pressure tested to 570 psi, then tubing pressure dropped to 305 psi in 1 hr (loss rate ~265 psi/hr), and annulus A builds up from 19 psi to 20 psi (1 psi/hr). From the investigation, it was concluded that the leak point was from thread connection between pup joint of DHSV (Downhole Safety Valve) and the full joint below, located at 183.4 mMD.

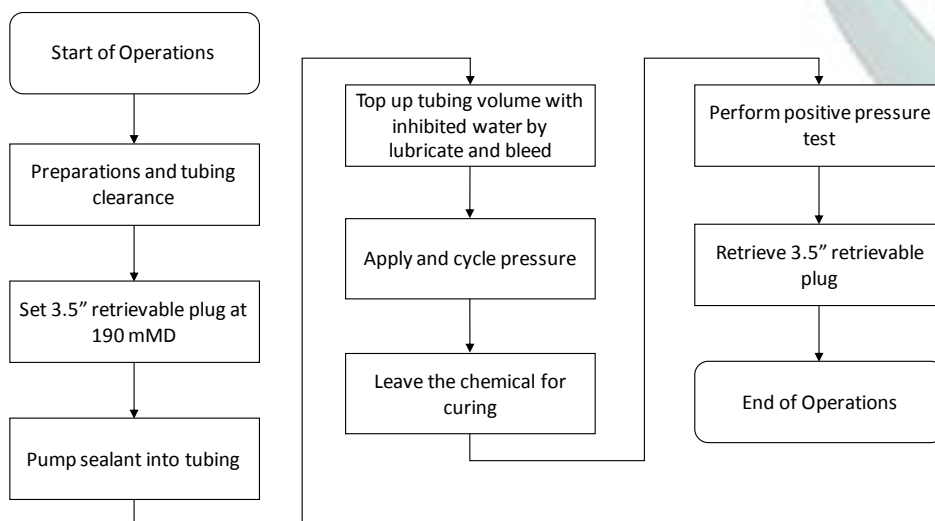
Figure 4. TN-x Pressure Activated Sealant Program Workflow

The flow chart of the program can be seen on Figure 4. The first step is to set 3.5" retrievable plug below leaking point at 190 mMD as the base for the chemicals. Then by using the available data (depth of leak, leak rate and pressure build up), sealant formula was designed. The chemicals will be pumped through Xmas Tree kill valve, followed by filling up the tubing with inhibited sea water by lubricate and bleed method. Once filled up, pressure will be applied to squeeze the sealant into the leak point with several pressure cycle to ensure the sealant has been activated. Then the sealant will be left overnight to cure. Finally, the tubing will be tested with positive pressure to ensure no more tubing – annulus communication. At the end of the operations 3.5" retrievable plug will be retrieved to return the well to its original state.

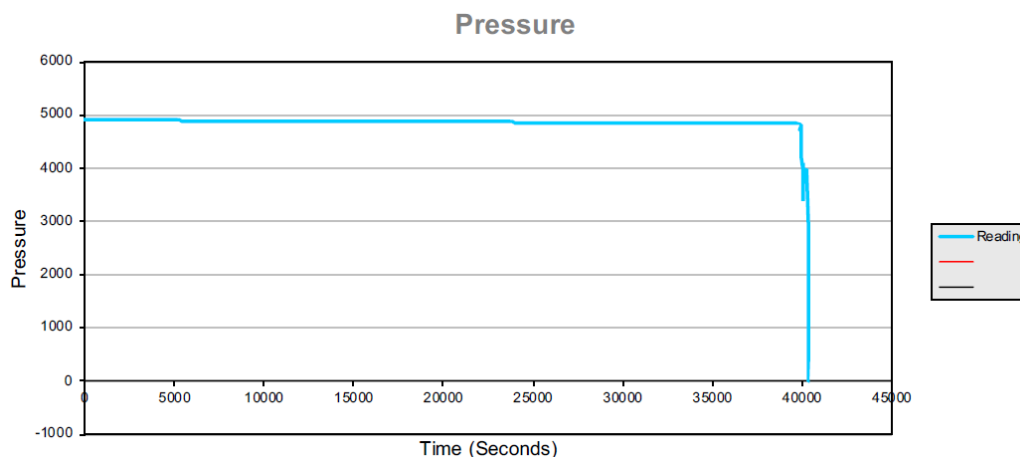
The tubing head pressure found in the following day was 4848 psi, with 77 psi of pressure loss occurred during the night (Figure 7). Then two pressure cycling was performed to ensure the sealant is activated by bleeding off THP to 0 psi and pressuring up back to 4925 psi (Figure 8).

Figure 7. Tubing Head Pressure record during overnight curing period (total loss of 77 psi)

18.30 – 00.00	Left the well overnight for curing.	
25-Sep-19	00.00 – 06.15	Left the well overnight for curing. As found pressure was 4848 psi (77 psi loss from overnight curing, <1 psi/min).

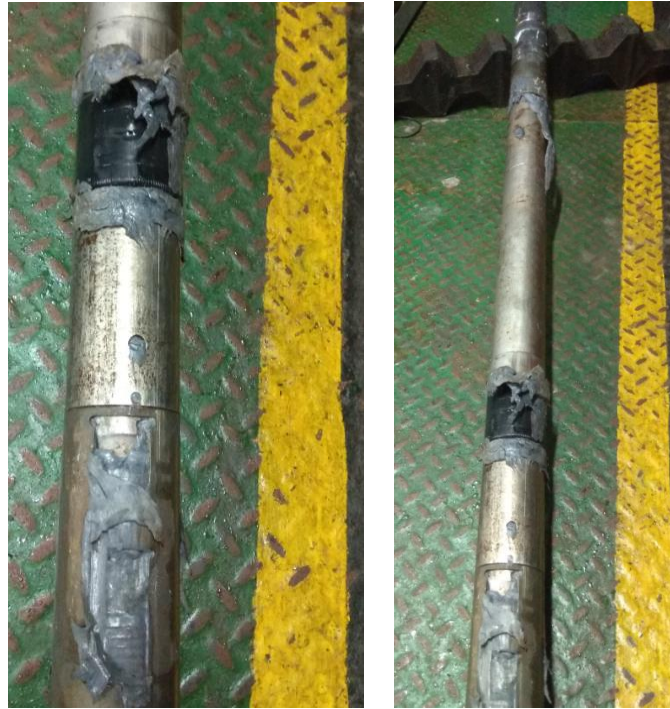
The final step of the program is to retrieve 3.5” retrievable plug from 190 mMD to return the well to its original condition. While POOH (Pulling Out of Hole) the plug, at depth 38 mMD, the plug stopped and got loss jar action. After several attempts the plug is finally recovered to surface with high pulling weight (1800 lbs). At surface, the tool string and plug was found covered with sealant residue (Figure 10). The residue was also found inside slickline BOP and Xmas tree.

Figure 10. Recovered plug was found covered with Sealant residue

The overall operation is concluded successful, with leak point is fully isolated. The obstacle was only found after the treatment while retrieving the plug. High pulling weight was observed with several loss jar action, and it turned out to be because of the “gelled-up” sealant residue inside the tubing string.

One possible explanation is because of the existence of small leak in the plug body that makes the sealant activated around the plug. However according to previous experiences of the provider, if the sealant was activated around the plug, it could be easily retrieved by jarring action and would not create the gelled up residue as in this case. But it is recommended to pull out the plug in a very low speed, to prevent the plug shearing the liquid around its surface.

Another possibility is because of the incompatibility between sealant mixture and well bore fluid. Sealant service provider has stated that the chemical is inert to almost all kind of well bore fluid, except chloride. Although there is low possibility of existence of chloride from brine/ produced water in the tubing on that depth, it is still recommended to take liquid sample inside the tubing and perform compatibility test. During several attempts in retrieving the plug, there was plan to pump friction reducer liquid. On-site compatibility test was performed by mixing sealant sample with friction reducer liquid. It is clearly seen that friction reducer reacted with sealant chemical and caused agglomeration, despite the claim that sealant mixture would be inert. Thus, it is highly recommended to perform compatibility test with well bore fluid and any intervention liquid prior the job.

Special precautions and thorough engineering study must be taken especially in the more complex case (e.g. deep leak point, high leak rate, etc). Operationally, it is recommended to: 1) ensure the base plug was in perfect condition with no leak to avoid the chemical activated around the plug; 2) perform compatibility test prior the intervention with well bore fluid, inhibited water, and any other fluid that is possible to be pumped inside the well bore during the operations; 3) avoid using small control line or any small diameter restriction in the pumping lines to avoid unintentional shearing effect in the chemical; 4) perform leak rate measurement using liquid (especially in gas wells) so that sealant mixture can be designed accurately.

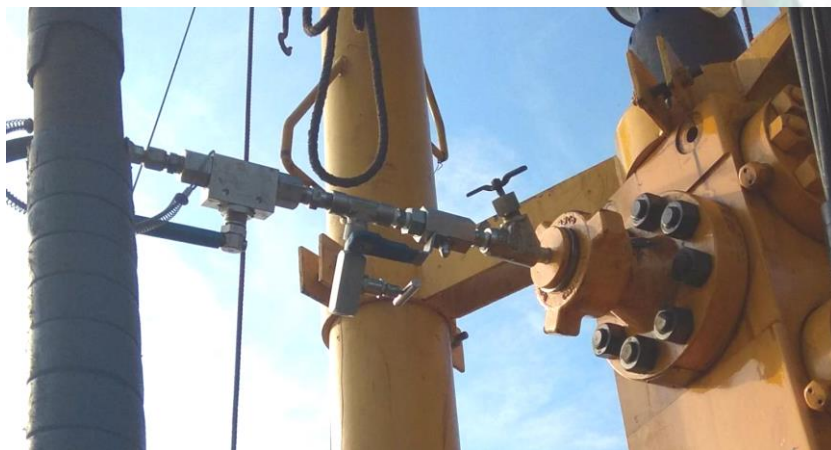
Another fact that the pumping operation was performed through needle valve that connects to ½” NPT (National Pipe Tapered) thread on the kill wing valve (Figure 11).

Figure 11. Connection of pumping line to ½” NPT in kill wing valve of TN-x

In the beginning of the operations this was considered as the most effective method so that there is no need to rig down the slickline lubricator after setting retrievable plug. However, the small pumping line could also contribute to unintentional shearing effect, meaning that the sealant is already semi-activated when being pumped down the tubing. Hence, it is recommended to use the bigger hose and connection in the pumping line to prevent any shearing effect in the chemical.

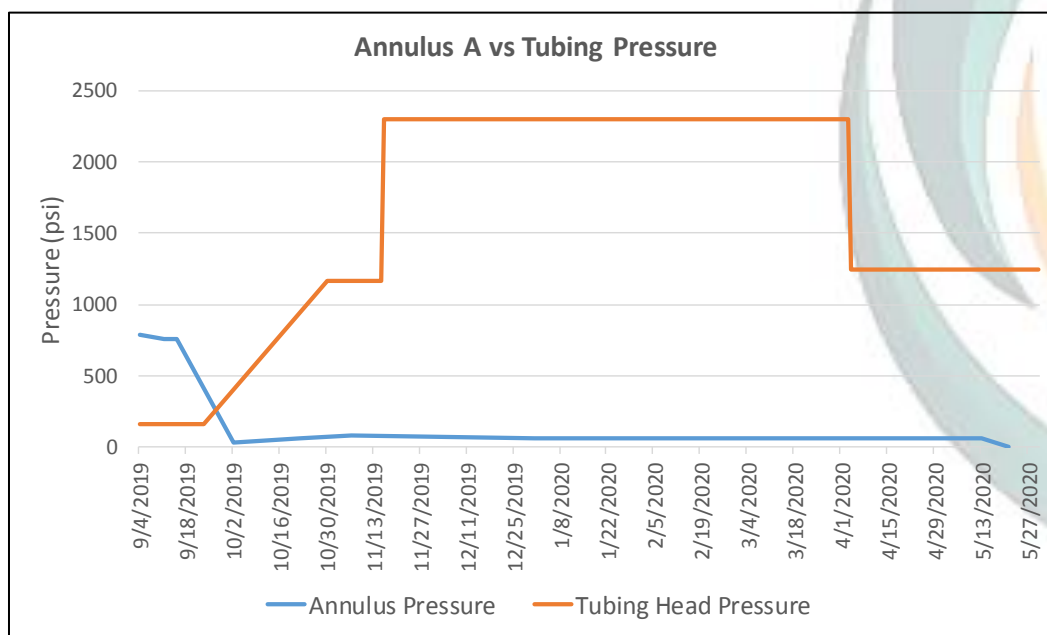
Figure 12 shows the record of annulus pressure since the treatment in September 2019 to May 2020. In more than 7 months after the job, annulus A pressure is stable at ~40 psi and no longer observed having communication with the tubing. Several well intervention jobs have also been performed in this well after the treatment, with no restriction encountered in the tubing.

Figure 12. Annulus A pressure is stable at ~40 psi after the sealant injection in September 2019. No more communication observed between Tubing-Annulus
