Lesson Learned: Fracturing Story Continues in Completely New Telisa Formation in B Structure South Sumatera

Reza Alfajri¹, Areiyando Makmun¹
 Pertamina¹

JOINT CONVENTION BANDUNG (JCB) 2021

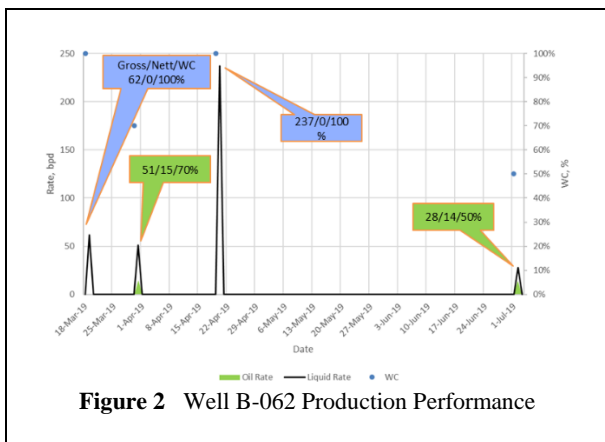
Figure 2 Well B-062 Production Performance

Telisa formation in B Structure in Pertamina was first discovered in B-062 well. This well was proven in producing oil, however it can't be produced continuously. Figure 2 shows that the well needed 2 – 3 months to be reproduced. Of course operational aspects were also considered to reproduce the well, but the events were evidence that the formation contains oil and the only thing needed was suitable completion method to produce the well continuously. Hence, hydraulic fracturing was then planned and performed.

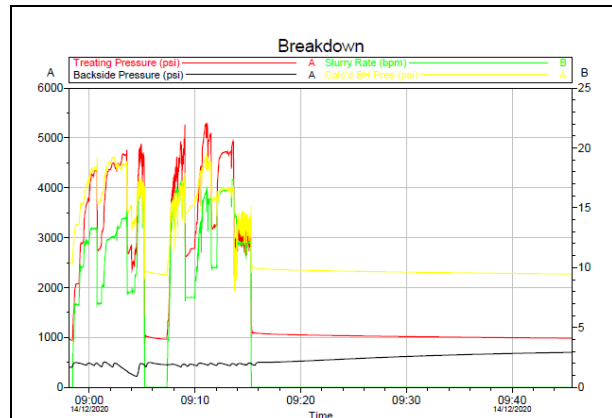
Figure 3 Breakdown Test Well B-062

Breakdown test was performed at maximum rate of 17 bpm with maximum tubing pressure of 5200 psi using 4% KCl brine. Total volume injected was 181 bbls. Based on after closure permeability was around 10 mD, tighter than what was predicted from petrophysical analysis. Fracturing design then would need to be switched from aggressive to conservative method with half-length as priority. Figure 3 and 4 show breakdown test pump chart and after closure analysis.

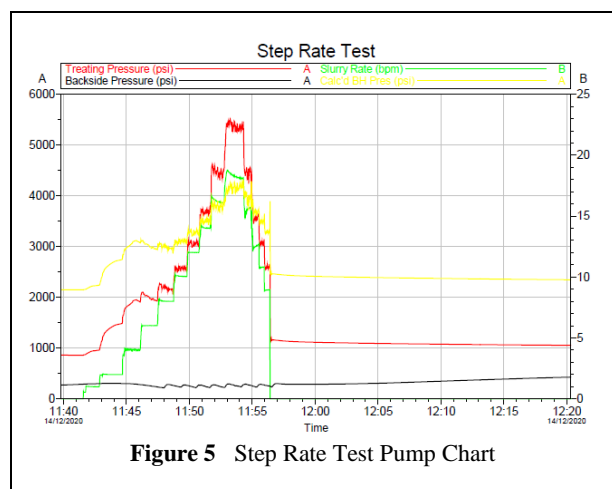
Figure 5 Step Rate Test Pump Chart

Step rate test was then executed to know fracture extension rate and pressure and near well bore (NWB) friction. Fracture extension rate and pressure was extracted from step up test and NWB friction was analyzed from step down test. Figure 5 to 8 show step rate test pump chart and the analysis. In Figure 5 step up test started at 1 bpm to 2 bpm for low point analysis and increased per 2 bpm up to 18 bpm. For step down test, 5 points were taken.

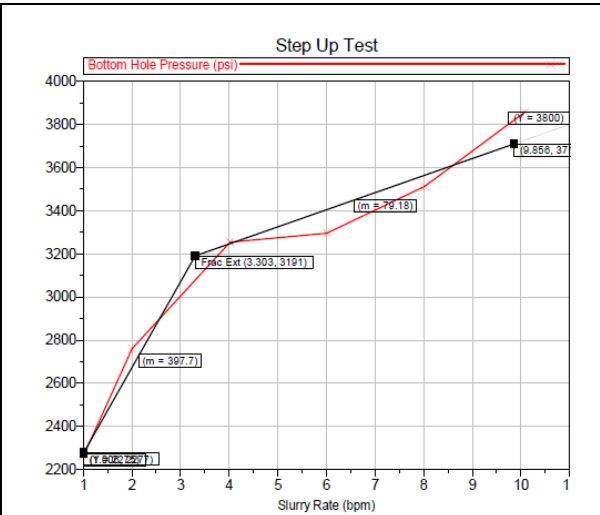
Figure 6 Fracture Extension Rate and Pressure Analysis

Figure 6 shows that fracture extension pressure was at 3200 psi and fracture extension rate was around 3.5 bpm. So as long as our pressure and rate are more than these numbers, our fracture will keep growing until designed length. Handicap for this well was shown in friction analysis result (Figure 7) that total entry friction for this well was more than 1700 psi. Figure 8 showed that total friction entry was in concave up shape, which means that entry friction was perforation dominated. In order to attempt to ease the NWB friction, hundred mesh (sand slug) would be pumped before pumping designed proppant slurry.

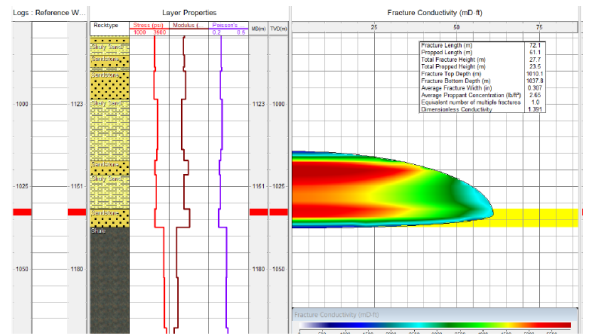
Figure 12 Fracture Geometry Design for B-062

Total proppant that would be pumped was 65 klbs 20/40 proppant preceded by 100 mesh sand slug. From fracture geometry design in Figure 12 showed that dimensionless fracture conductivity (FCD) was more than 1.2, fracture width was more than 0.2 inch, and average proppant concentration was more than 2 lbs/ft². These three parameters showed that this design was quite good and ready to be executed.
